**Re: Cherry Grove Phase 4**  
MS4 – City of Spring Hill  
NPDES Permit Number TNS080055  
Williamson & Maury Counties

**Re: NOTICE OF VIOLATION**

Cherry Grove - Phase 4  
TNCGP Tracking No. TNR145340  
ARAP Tracking No. NR0704.058  
Williamson County

**Compliance Inspection for General NPDES Permit for Stormwater Discharges from Construction Activities (CGP)**

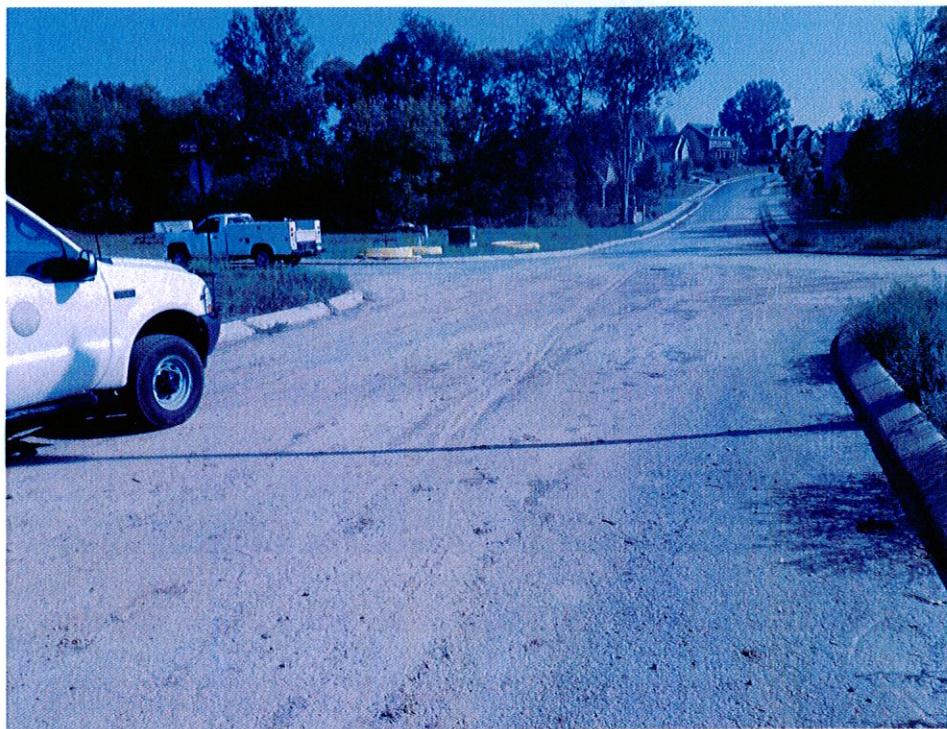
During the follow up inspection on September 12<sup>th</sup>, sediment was observed in the street at the corner of Stewart Campbell Pointe and Brisbane Drive. Recent rains had transported sediment to the storm drain inlets which discharge to an unnamed tributary of West Fork Aenon Creek. The inlet protection was unmaintained and failing. The majority of the sediment appeared to be coming from where Stewart Campbell Pointe dead ends and from current house construction taking place at the eastern end of Brisbane Drive. An onsite worker indicated that equipment hauling dirt from a stockpile was the likely source of the sediment in the road at the end of Stewart Campbell Pointe. No construction entrance/exit was observed where trucks entered the paved street.

View of sediment in the street at the intersection of  
Stewart Campbell Pointe and Brisbane Drive.

- Remove sediment from the paved streets and install properly functioning inlet protection.
- Install a proper construction entrance anywhere equipment is entering/exiting the unstable portion of the site onto a paved surface.
- Install proper erosion prevention and sediment control devices to ensure sediment is retained on site in all areas where active construction is taking place including current home construction
- Address all deficiencies in the storm water outfalls to achieve compliance with the subject ARAP. Outfalls must be constructed in a manner which will not cause permanent alteration or damage to the stream channel. All channels must be properly stabilized.

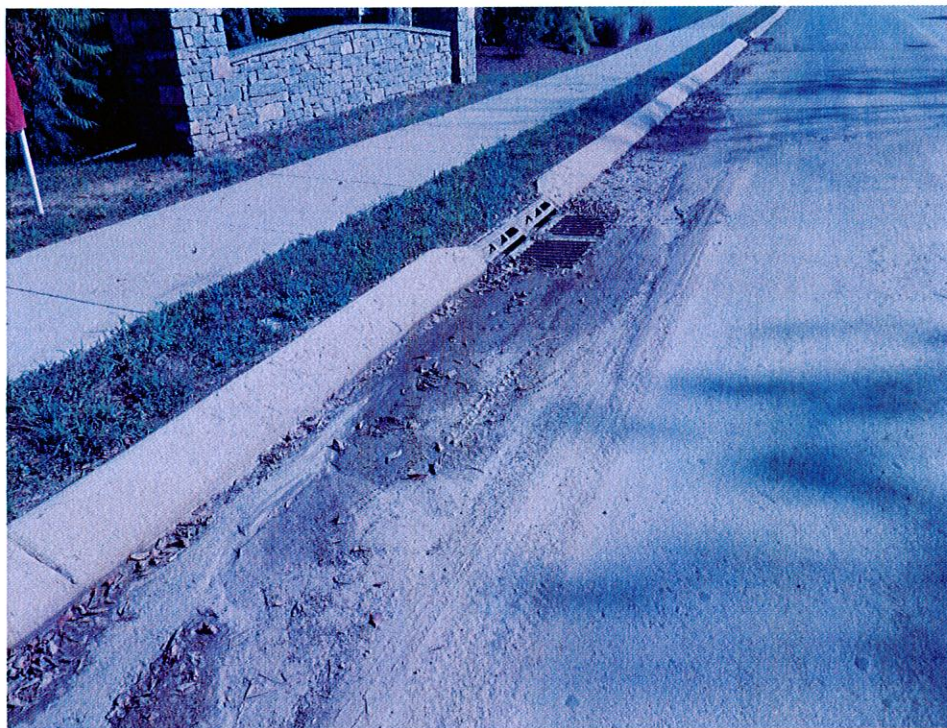
View of sediment entering the storm drain on Stewart  
Campbell Pointe.

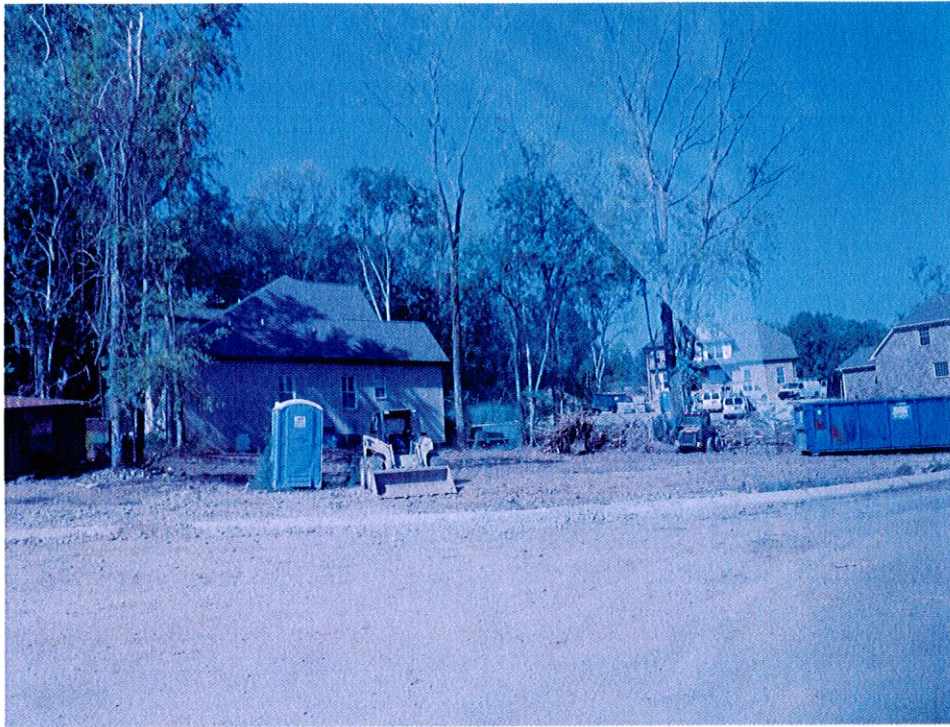
View of lot clearing with no EPSC Devices and sediment being tracked into the street.

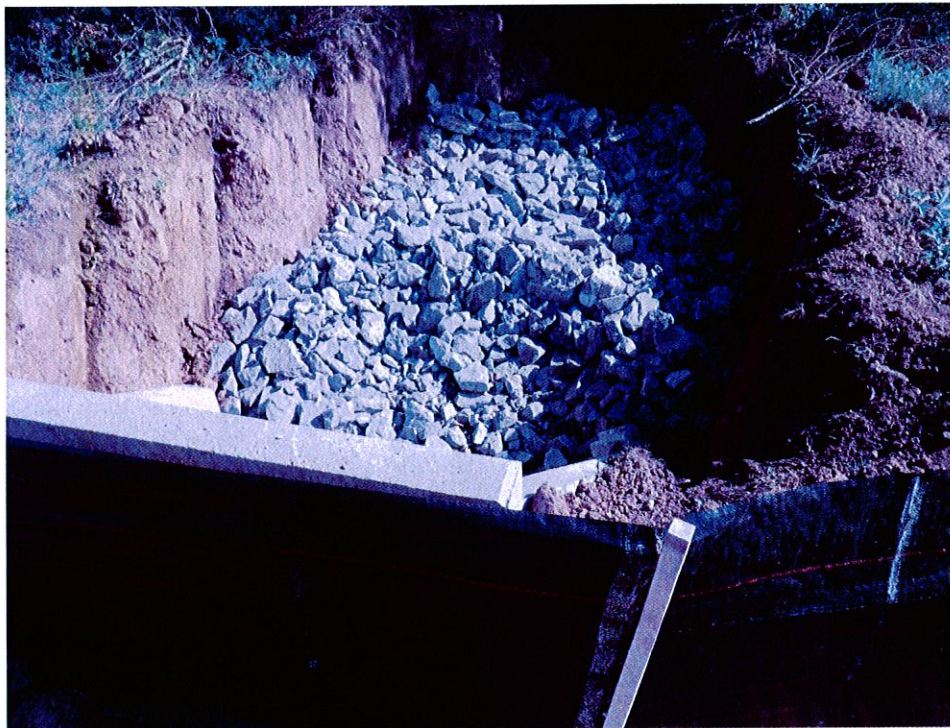
Additionally, it was observed that the storm water outfalls entering the tributary were not in compliance with the Aquatic Resource Alteration Permit (ARAP) (NR0704.058). The channels cut from the storm drain headwalls to the unnamed tributary of West Fork Aenon Creek exhibit vertical, unstable banks. The rock used in the bottom of the drainages is undersized and is likely to be transported into the stream during heavy rains. Additionally, the outlets of several of the outfalls discharge at a higher elevation than the stream channel leaving the potential for head cutting and severe erosion.

View of stormwater outfall channel with vertical unstable banks.
